Residential Refrigerator Install

2005 Dutch Star
Terry McKnight
December, 2010

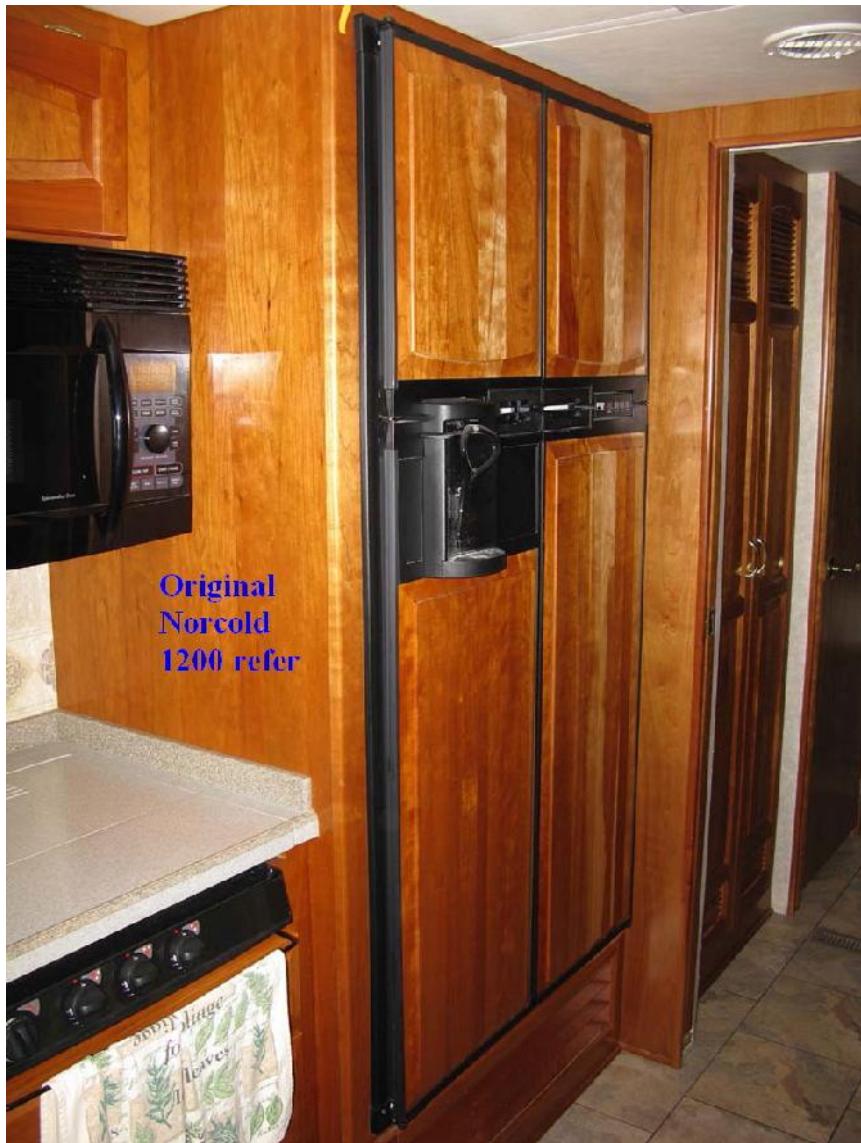
This Maytag is about 5 ¾ inches taller than the Norcold it was going to replace as well as about 3 ½ inches wider. In our rv this was going to require cabinet modifications for the install. Additionally, I was going to have to relocate or re-route a water drain line, hot & cold water lines, and the furnace propane line that happens to run under the original fridge support floor and over top of the furnace. They would have to be moved so that the new support floor could be lowered about 5 inches. Here's the old Norcold that was removed.

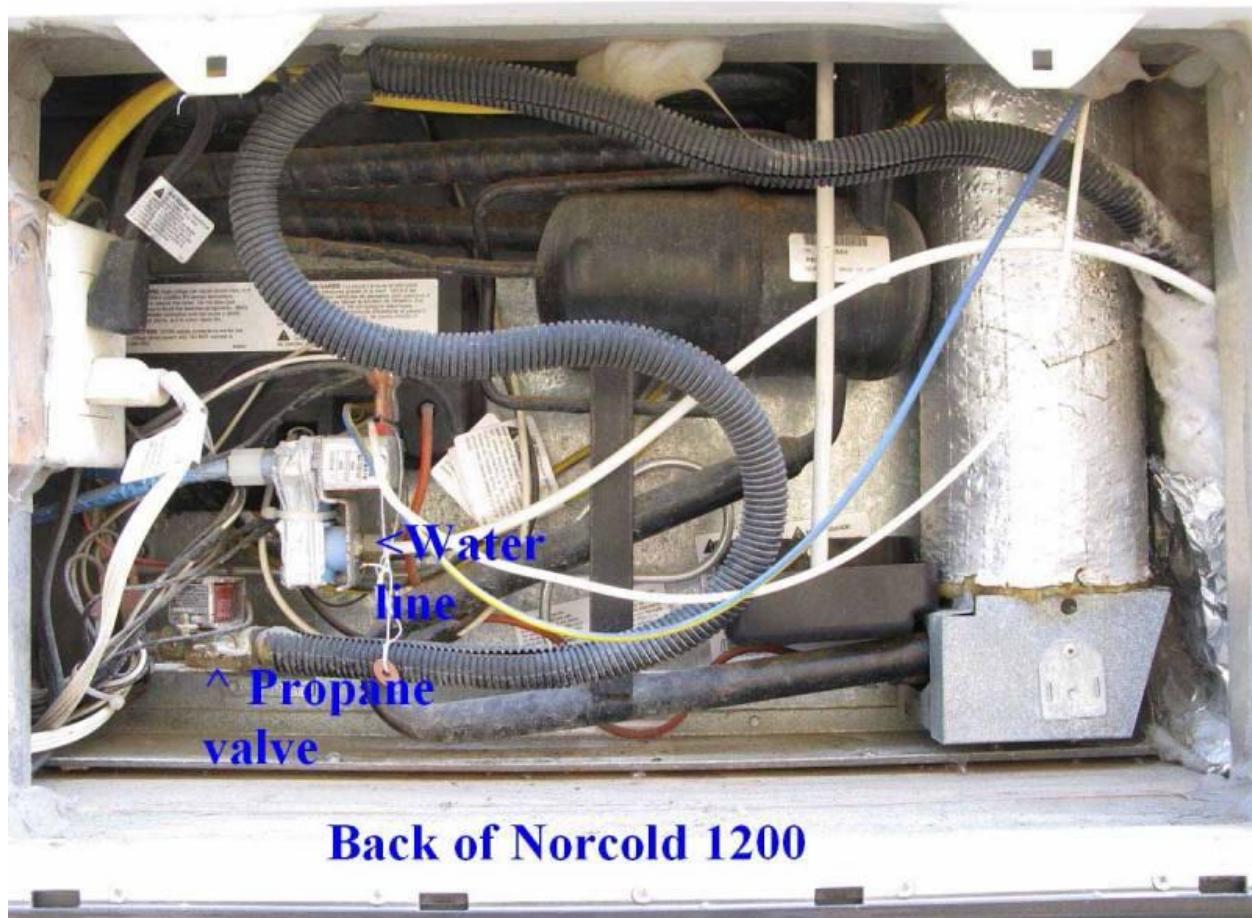
The first step was to get the Norcold out. This picture shows the back of the Norcold as viewed through the outside access door.

I turned off all power to the rv, and then disconnected the 120v and 12v lines to the fridge. All other connections to the fridge control board were pulled, then the water line for the ice maker. Prior to disconnecting the propane line, I closed the valve at the propane tank. Next 3 screws that were used to secure the Norcold to the support floor were removed to allow the unit to be slid forward. Fortunately Newmar does not glue their fridges down like some manufactures so I did not have to struggle with breaking any glues.

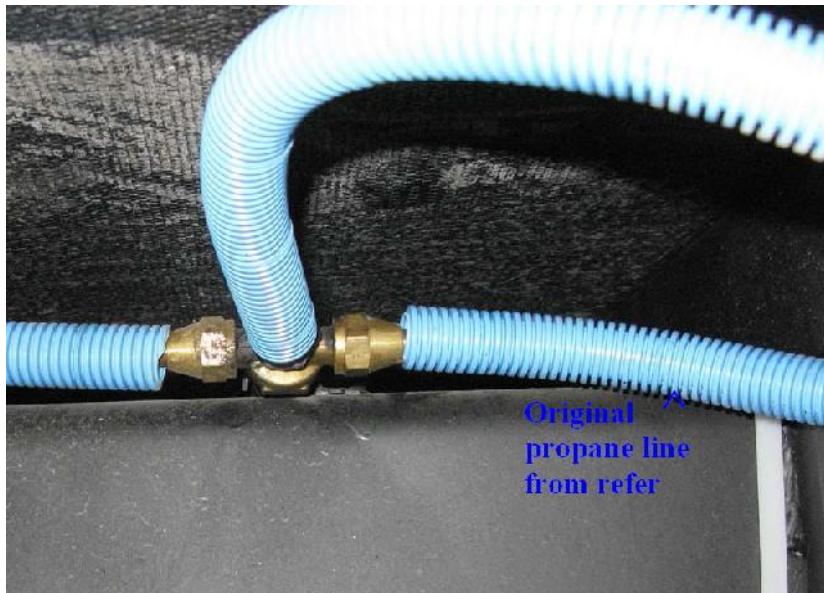
[Propane junction]

After the fridge was removed, I needed to remove the propane line that supplied the rv fridge. After identifying the correct line in the basement, I

removed it and capped it off at the junction in the basement. Pipe tape for gas lines was used on the threads. Later I checked for leaks with a soapy solution.

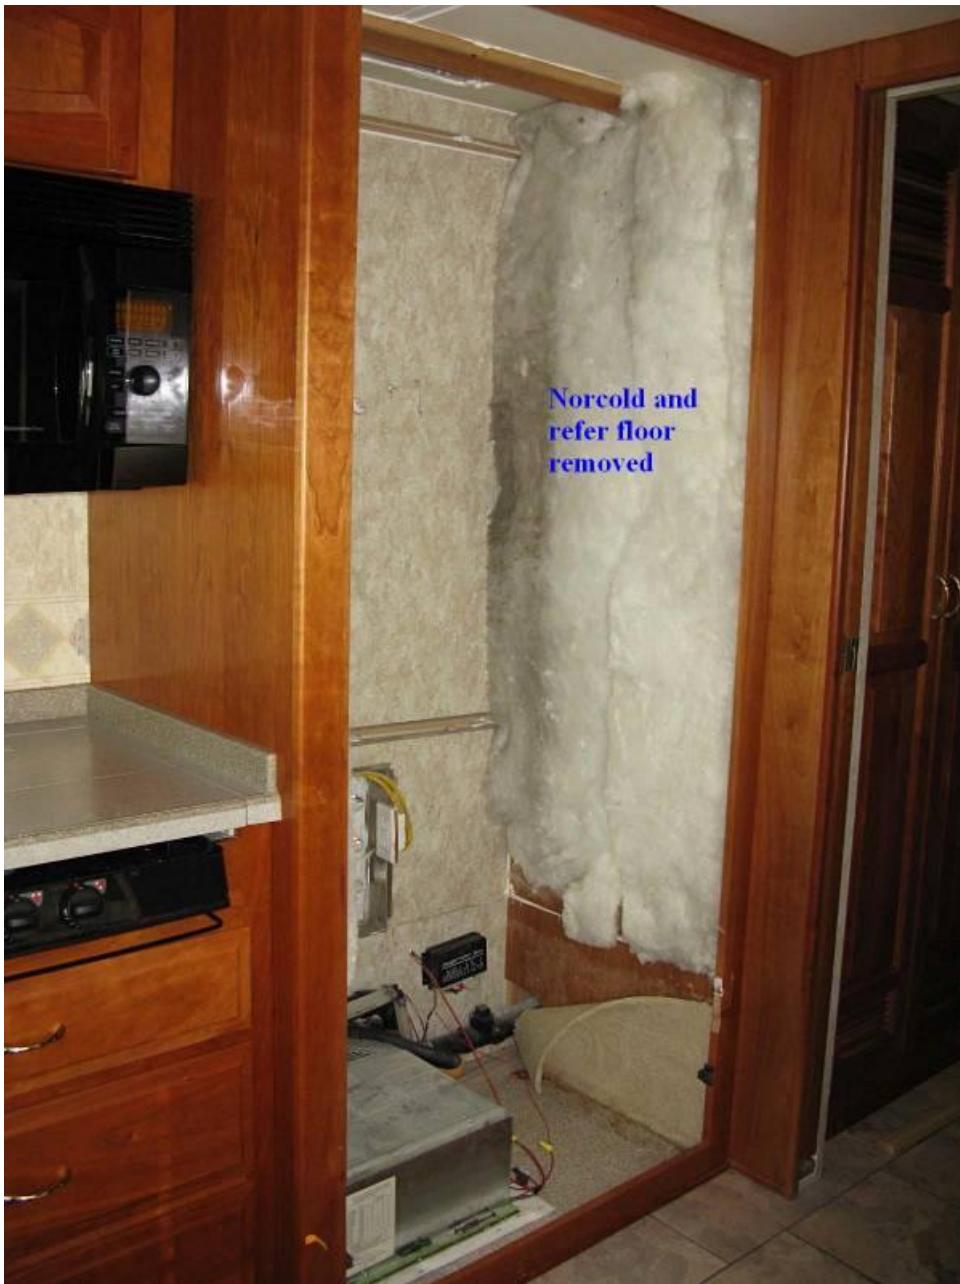
Next I had to remove the original support floor that the Norcold rested on. This proved to be more difficult than I anticipated. Newmar had the floor stapled, screwed, and glued in place. It was a pain but I got it out and even managed to salvage the bottom trim piece for reinstallation later.

Here's the cabinet with the floor removed.

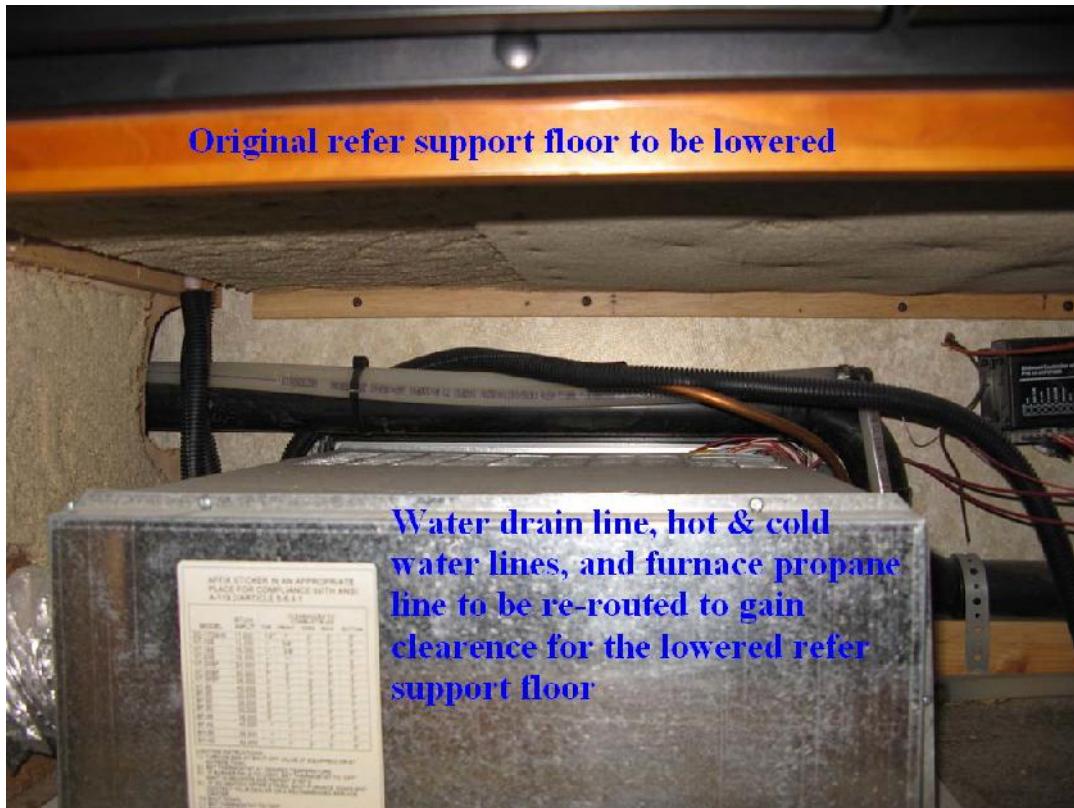
Before the new floor could be installed I had to move the drain line that comes from the kitchen sink and runs over top of the furnace. I also had to reduce the height of the hot and cold water lines and then carefully reposition the copper propane line the feeds the furnace. All this was necessary to gain the needed clearance for the new lowered fridge support floor. Here's a picture of the plumbing prior to relocation.

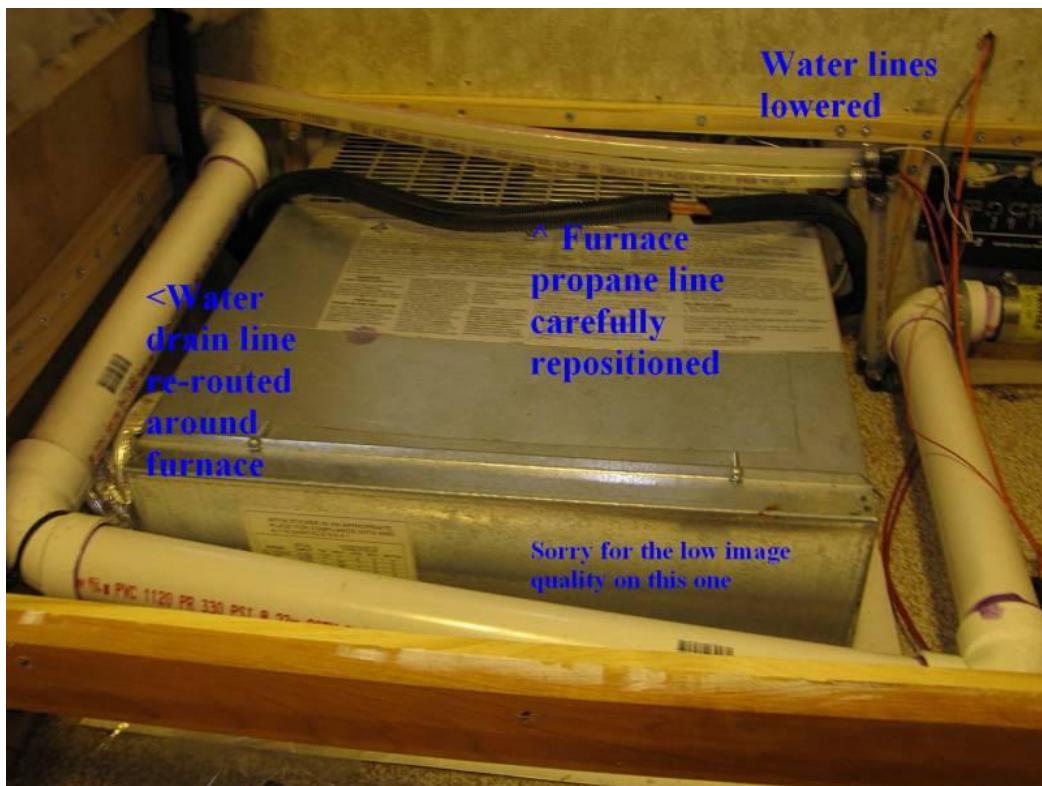
Here are the relocated lines. Unfortunately the photographer (me) did a poor job on this photo. To gain the necessary clearance I had no choice but to run the water drain pipe around the furnace.

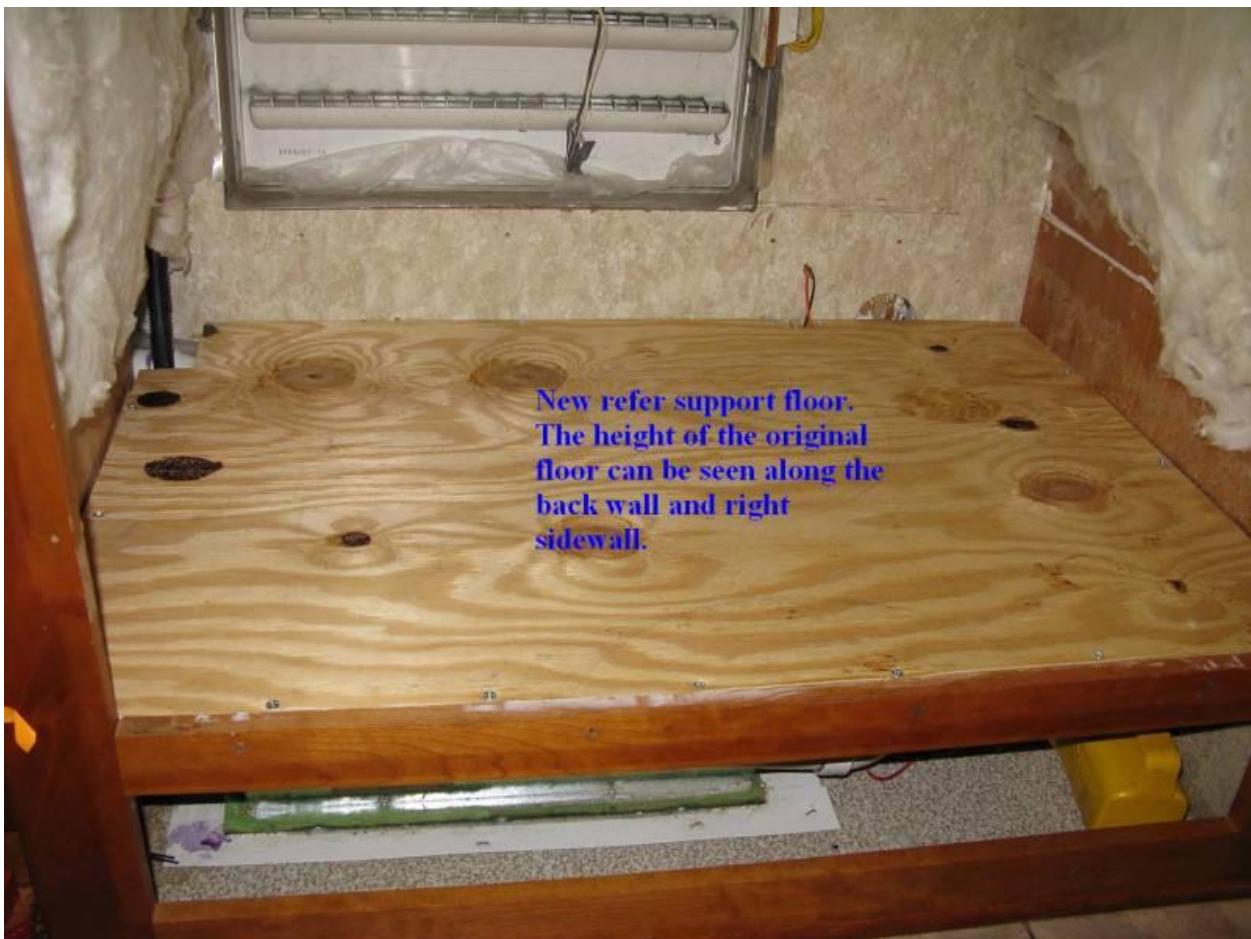
The next picture shows the new support floor installed. I used additional support around the perimeter and one vertical support under the floor placed near the furnace (near the center of the new floor) to give additional strength to the floor.

Not shown in the picture is the cover I placed over the hole in the back wall and the sealant I used around everything along the back wall.

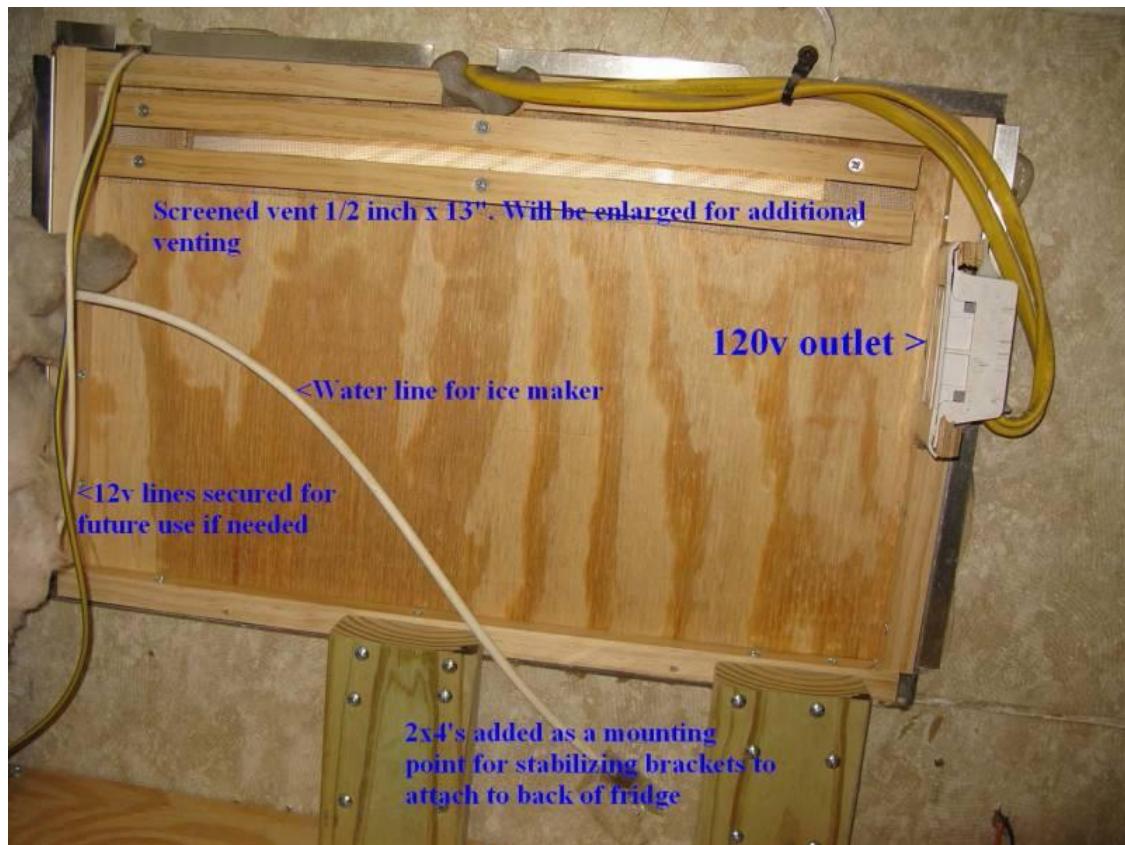
Next I fitted a piece of wood to close off the outside access door. This is to reduce weather and bug entry. The new cover is removable from the outside. It is equipped with a $\frac{1}{2}$ inch wide by 13 inch long screened vent to allow some venting. I'm going to enlarge this vent to allow more venting based on our 9 day trial run after this install was completed. The original overhead vent was left open.

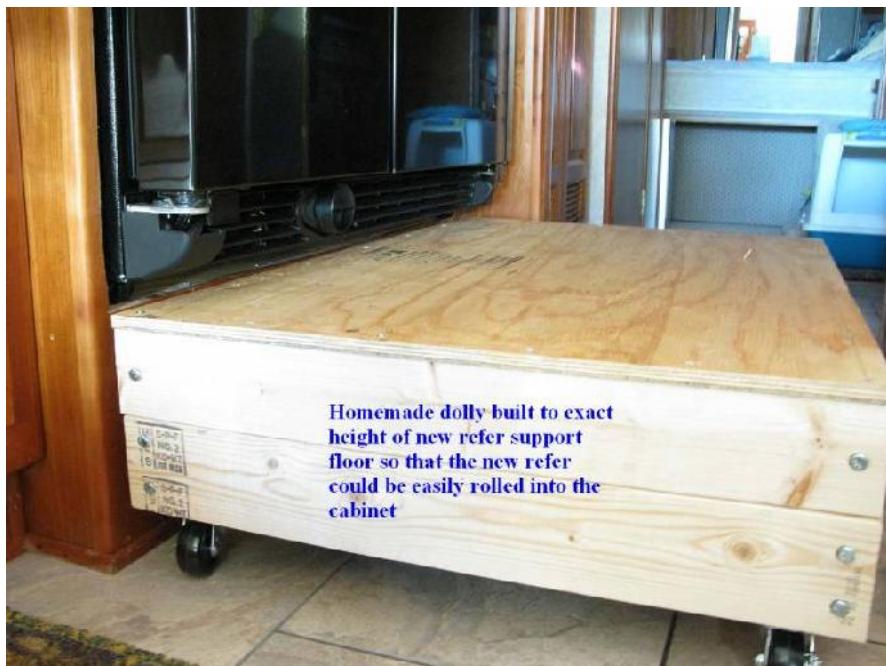
The dolly was made to top out at exactly the same height as the new fridge support floor. It has casters on the bottom for ease of movement. The idea was to place the fridge on the dolly with 4 people lifting and then move it up to the cabinet. This worked well. It was easy to roll the fridge into place in the cabinet. No one had to strain anything for this install. By the way, since the dolly is essentially a box on wheels, I plan on turning it upside down in our motorhome basement and using it as a box. That way it will be with us all the time. Should I need to service the fridge in the future I can just roll the fridge out on to the dolly and spin it around as necessary. Here is the dolly in place after the fridge was slid back into the cabinet.

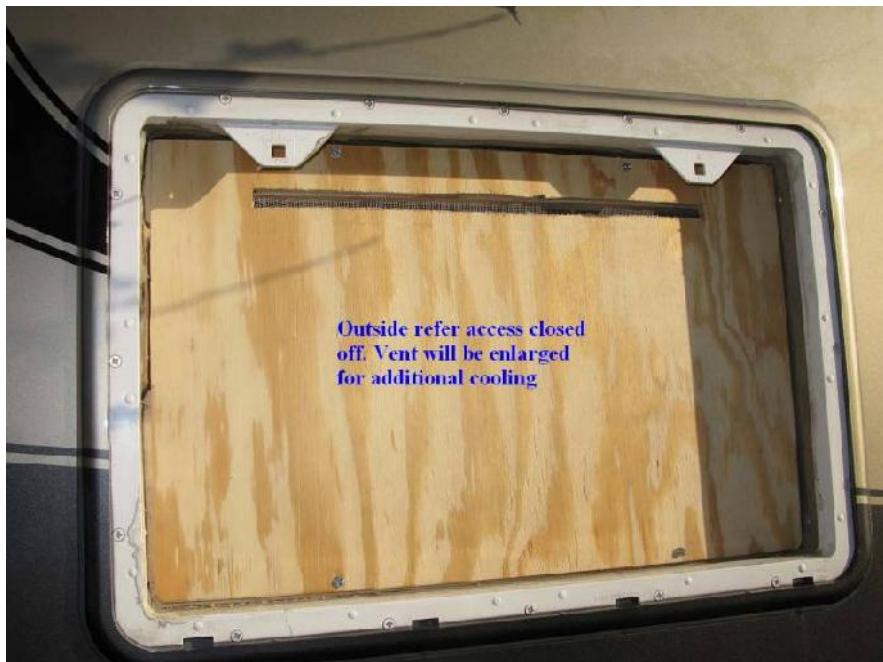
Here's a picture of the access door cover in place. The original outside cover fits in place and hides this cover.

Outside, working through the access door behind the fridge, the water line was connected and the power cord inserted into the outlet. I also used a couple of brackets to attach to the back of the fridge to help hold it in place. I'm going to use some additional methods to secure the fridge, but I've not figured out what I'm going to do.

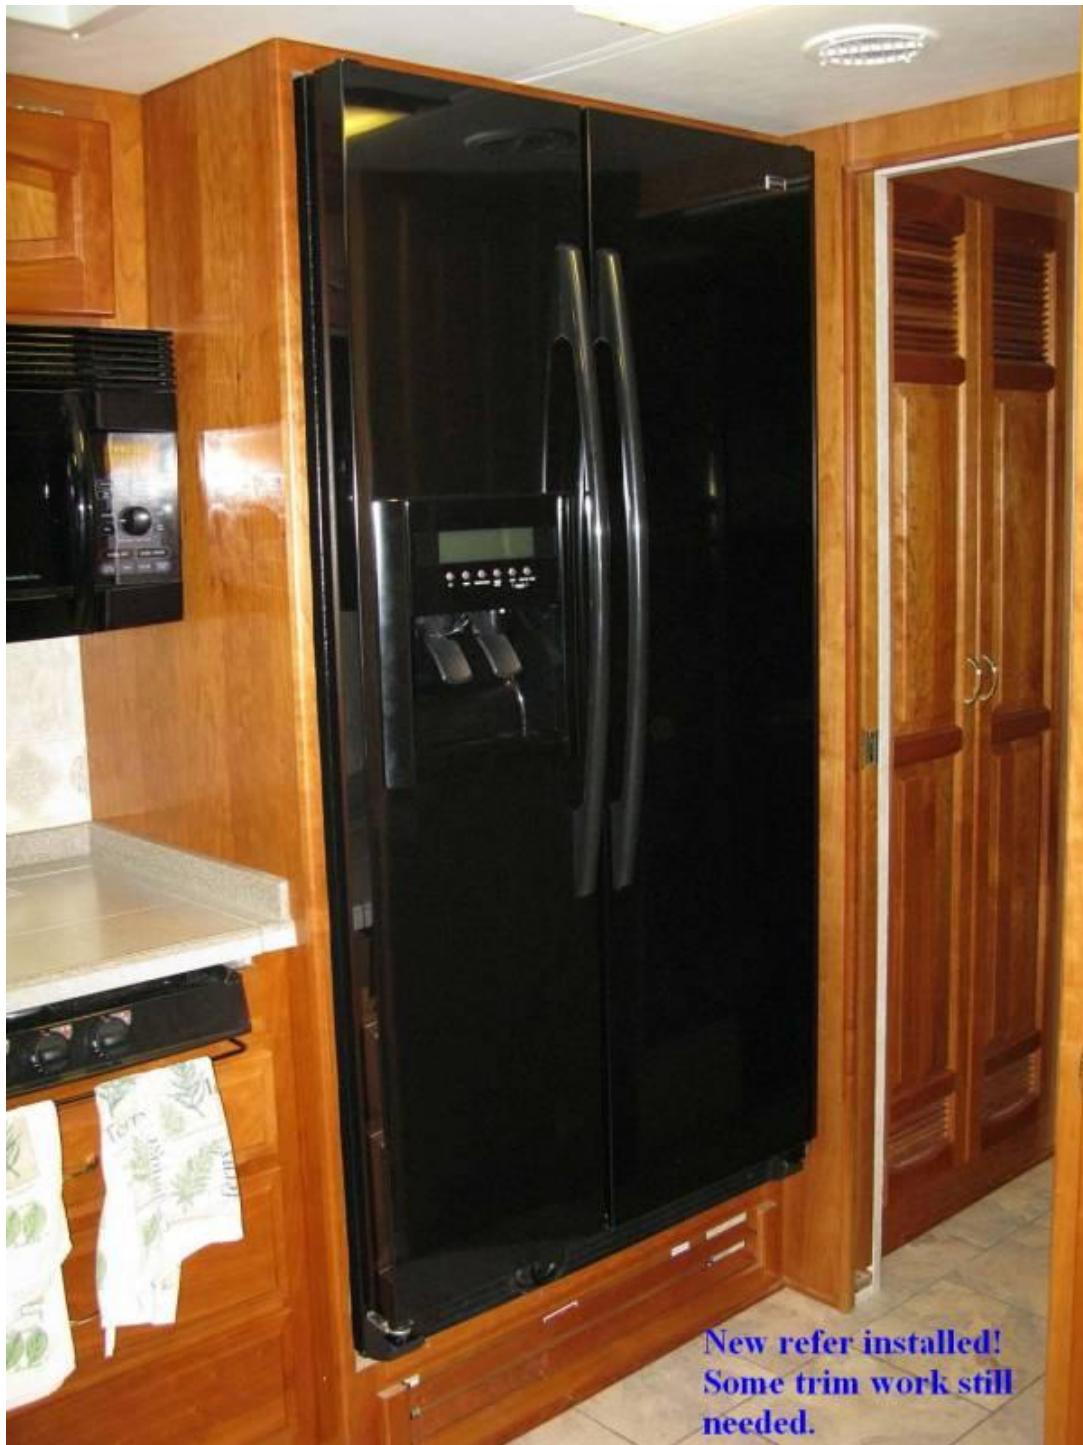
Finally, here is the new refrigerator installed in the motorhome. There is some trim work to be done yet, but it is up and running.
