Workhorse Custom Chassis Service Bulletin

Bulletin Number: 50902-I

Subject: Safety Recall 50901-C Interim Repair Procedure

**Models: All W20, W21, W22 Models Produced from July 24, 2000,
through December 19, 2007, and Equipped with Bosch ZOPS
or ZOHT Hydraulic Disc Brake Assemblies**

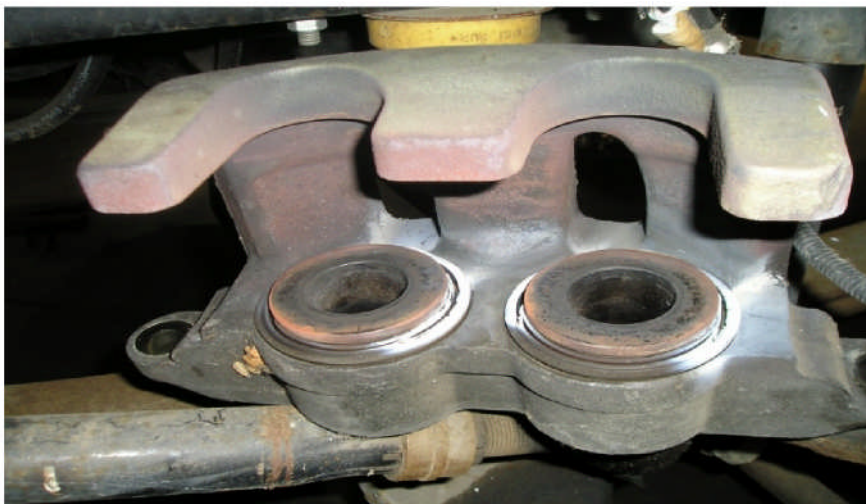
- To assist in identifying a caliper assembly that is experiencing degraded performance that may be related to this safety defect inquire about and/or look for the following:
 - Customer complaint of a distinct brake burning smell;
 - Complaints of having to apply more engine power to overcome an unaccounted for slowing of the vehicle that is commonly associated with brake drag;
 - An ABS light that is on continuously and/or a heat damaged sensor;
 - Smoke coming from the wheel end;
 - A soft or spongy feel when applying the brakes;
 - Piston dust seals/boots that are cracked or appear discolored (white powder markings);
 - Front wheel seals that show signs of heat damage; and
 - Front spindle caps that show signs of heat damage and leaking.
- White residue on the piston dust seal/boot and caliper

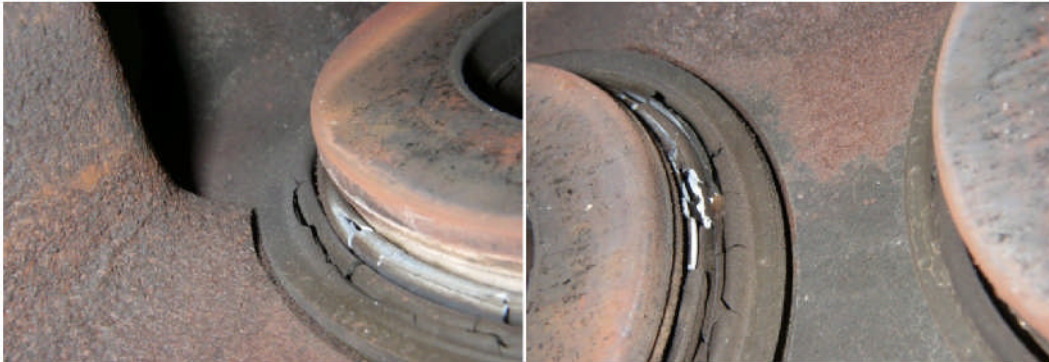
- **Cracked piston dust seal/boot (white residue may also be present)**

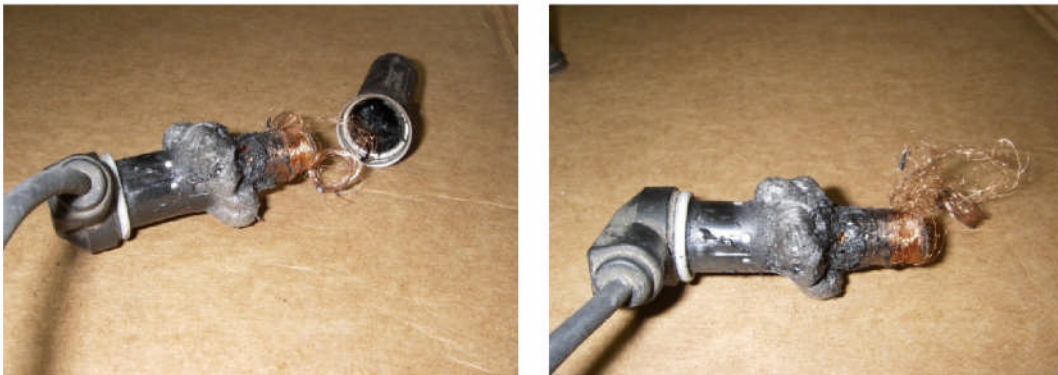
- **Heat damaged ABS system wheel speed sensors**

ABS sensors experiencing heat damage that may be related to the safety recall have stopped functioning at various speeds and may have intermittent or complete loss of functionality and associated fault codes.

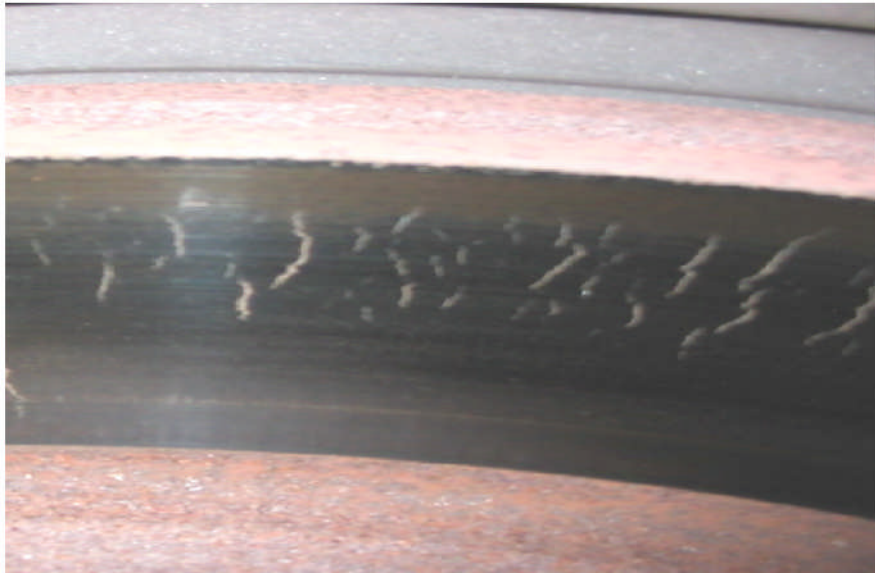
- **Rotors with radial cracks and “star” cracks have been evaluated and are not considered collateral damage. The following are several factors that can cause rotors to crack that are not related to this safety defect:**
 - “Riding” the brakes downhill;
 - Absence of a tow car brake system; and
 - Continued “hard” braking.

- Short radial cracks on the rotor surface that comes into contact with the brake pads (“heat checking”) is caused by heating and cooling of the disc during normal operation. No corrective action or replacement is required.

The existence of cracked rotors as described above, and without any other evidence (see additional items described below), would not justify a caliper replacement per the interim letter – neither would the replacement of the rotor qualify for a goodwill policy replacement. A replacement of the rotor under these conditions would be the responsibility of the customer.

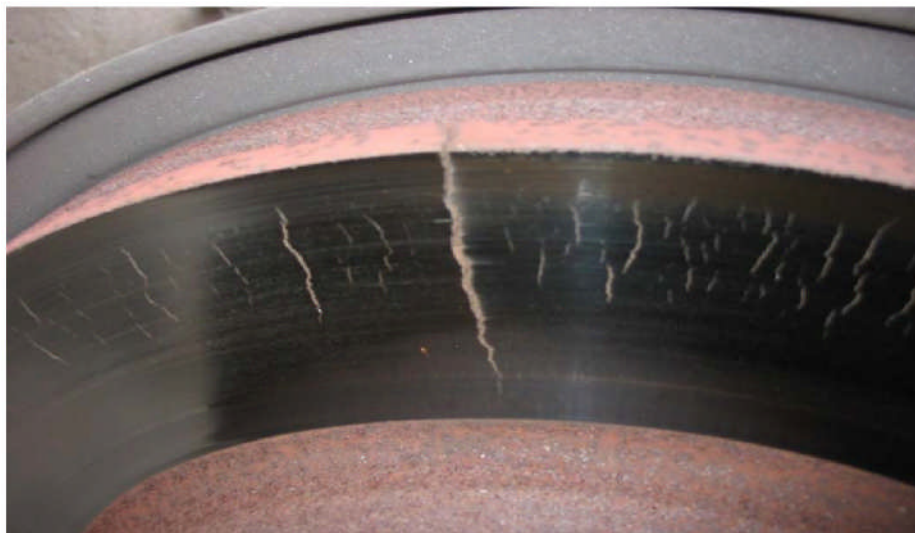
- A rotor with a large radial crack that has migrated through the outer surface, as shown below, will need to be replaced.

Again, without any other evidence of damage that may be related to the safety defect, the replacement costs for this condition would be the responsibility of the customer.

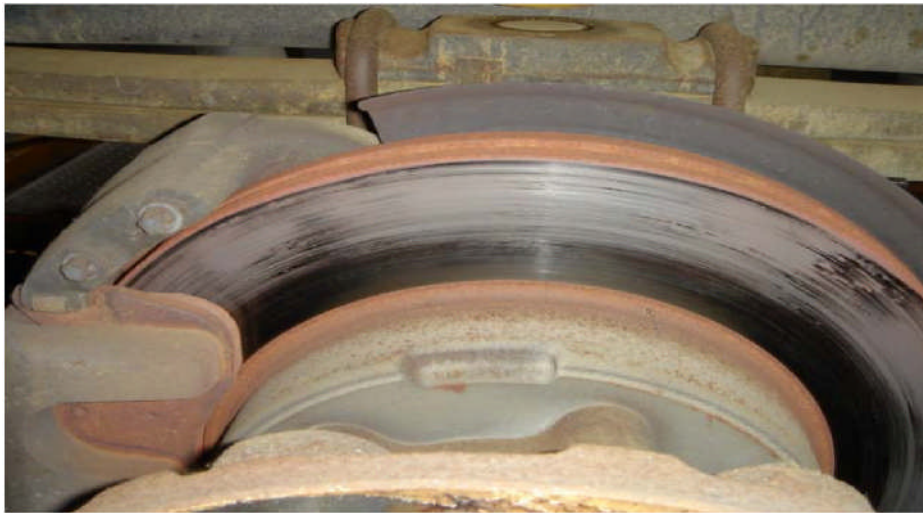
- Rotor colors vary from vehicle to vehicle. The rotor below shows some normal discoloration and light transfer of brake pad material. If necessary, the rotor may be machined during a related interim repair but does not require a mandatory replacement. Rotor thickness will have to be measured to verify it is within the specified minimum thickness prior to turning.

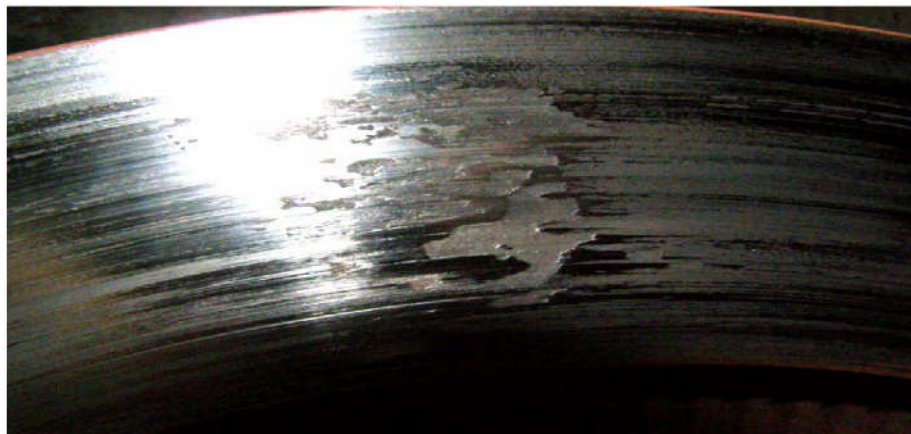
The rotor shown below exhibits severe brake pad material transfer and is a good indicator that the brake caliper assembly at this wheel end had experienced brake drag that may be related to the safety defect. The excessive amount of brake pad material transferred on to the rotor would be considered collateral damage and will require the replacement of the rotor. The associated cost is covered by the interim repair procedure if a caliper failure has occurred.

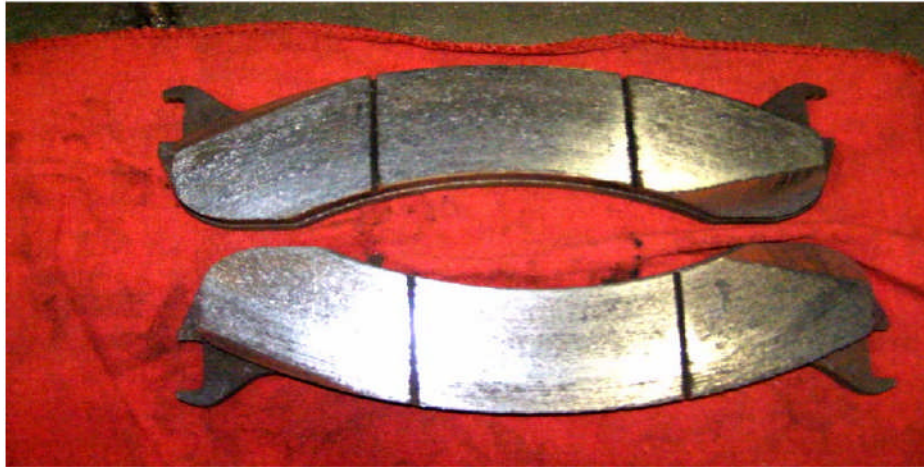
- Pads below show normal brake pad wear noted by a smooth surface with no resin or material transfer from the pad. No repair action is required.

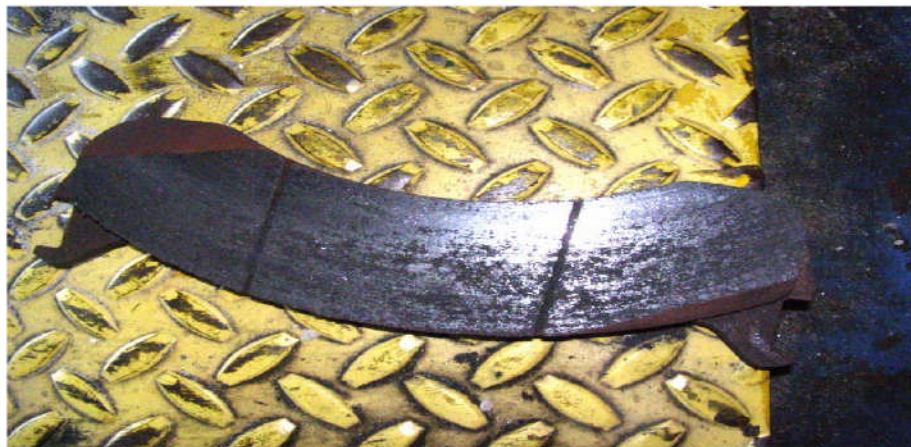
- The brake pad shown below exhibits the rough/damaged surface typically associated with material transfer from the pad to the rotor due to excessive heat. The corresponding rotor will most likely exhibit corresponding material deposits from these pads. Replacement of a brake pad in this condition is considered collateral damage and is covered by the interim repair procedure.
