## Repairs to Jayne Murray's Artic Fox trailer by Ron Marabito

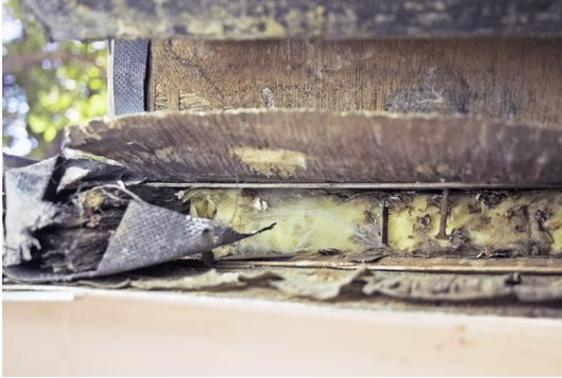
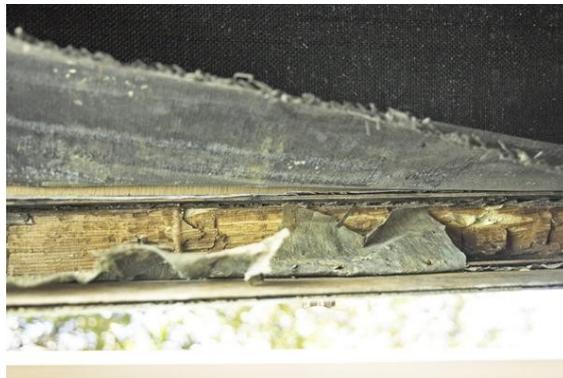
The first two photos show dry rot in the sidewall below the floor.

I believe we can successfully treat the rot and then re-build about 60% of the wood with epoxy putty. I will attempt to replace the balance of the wood with new treated lumber and some more of the epoxy putty. When that is done, I will fiberglass the rear side up to the floor and then finish the bottom off with the original plastic channel trip.

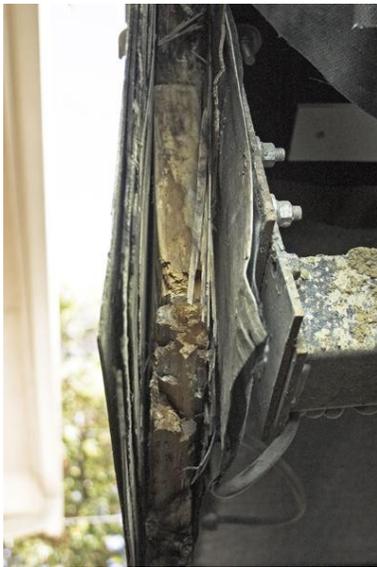
This image was taken at the forward edge of the wheel well. Very poor construction in my opinion.

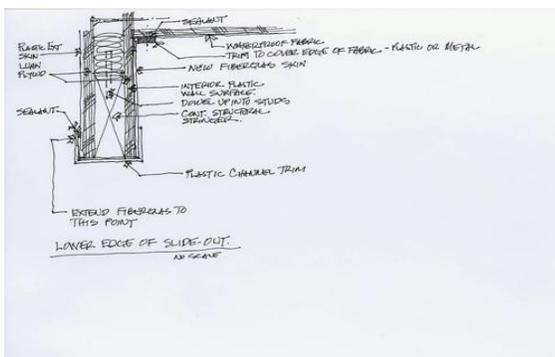
I got underneath and removed the Luan Plywood from the back side of the wall for the slide, which is below the floor. This Luan is only 1/8" thick. I plan to replace the Luan, but I also have to extend it behind the slide mechanism. The only way to do that is to remove the angle that supports the floor and retract the slide mechanism.

I plan to either block up the slide and remove the mechanism or pull the slide in about 3/4 of the way and let it rest there, as it appears to simply slide and rest on the carpet. If I bring it in, I have much less room to work as I will have to do all the repairs in that position. I decided to support it in the full out position. In order to properly re-align the mechanism when I finish, I will spray paint the edges of the plates and

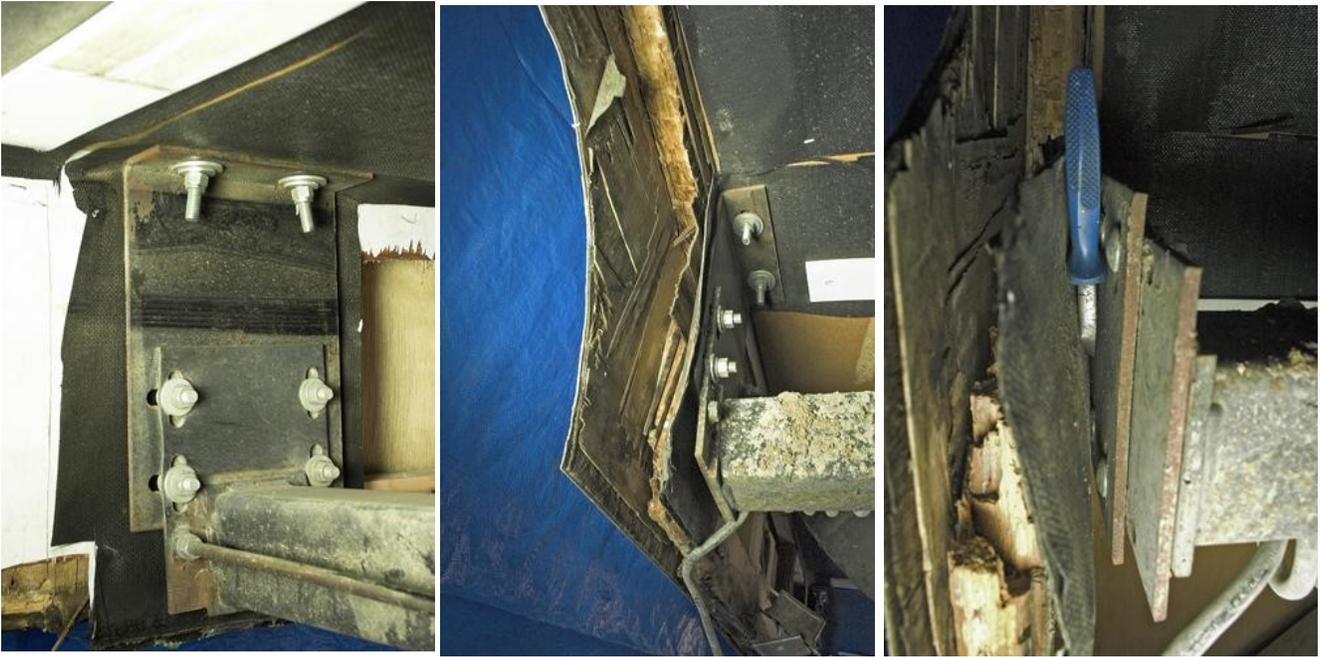
Here's a sketch section of the lower wall to show you the construction. Note: that the bottom channel that I thought capped the bottom, is only a metal angle trim and does not extend up the back side of the wall. I hadn't seen it until yesterday.

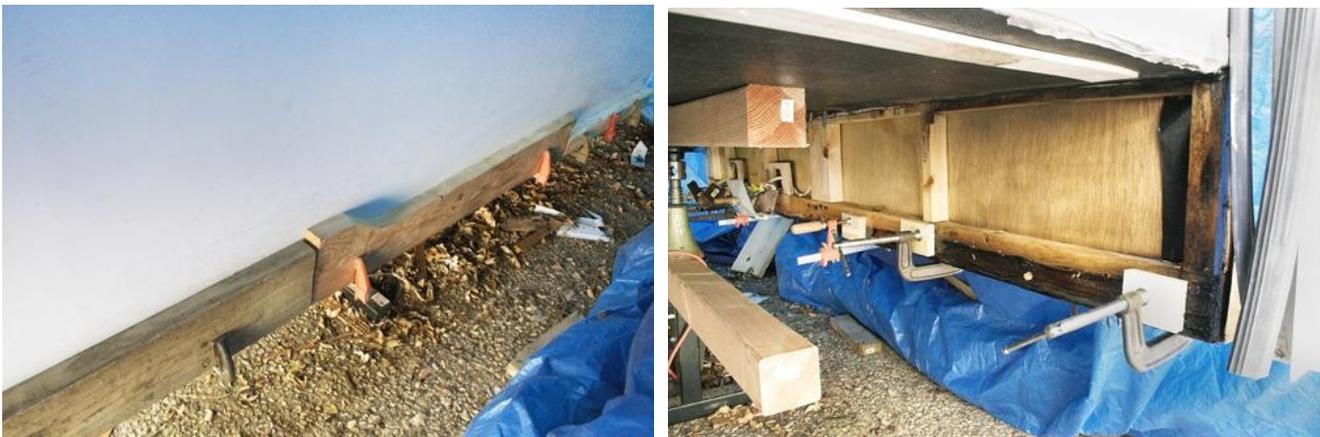
On the outside, with some assistance from Jack Pearce, I impregnated some resin in open cavities and drilled holes to solidify the wood some more. A layer of resin was then applied to the exposed rotted wood and between the framing and the exterior plywood skin. That was then clamped as shown in the photos. Because the temperatures are pretty cool at night, I plan to leave the clamps on for another day, but will probably start building some of the wood up with the epoxy putty. It can be applied before the resin is completely cured. I have not worked with this product before, so I hope it works as good as they claim.

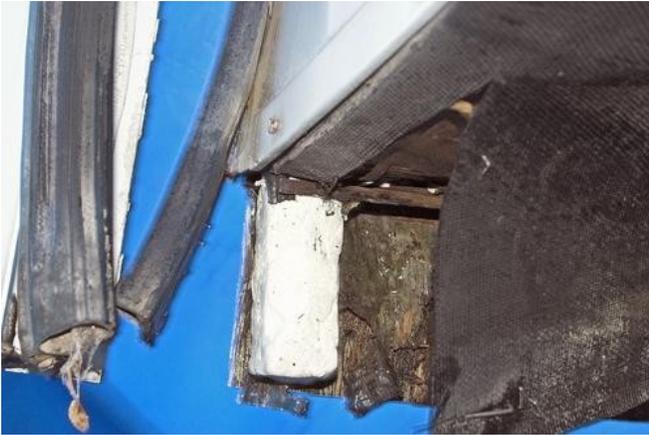
I applied the epoxy wood putty along the bottom rail of the slide out except where a few of the clamps are located. I have attached photos. This was all hand shaped. It tends to stick to the putty knife and the product I am using did not provide information on what to use to smooth the surfaces. I will probably have to do a little refining of the putty with a new application. Tonight, I will check their web site to see what I can learn to make it easier. It can be sanded after it is hardened and should perform just like wood.

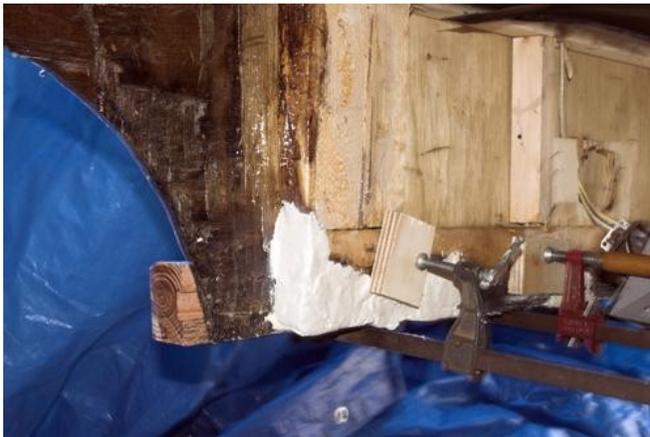
We are making progress. I plan to cut the lower frame member for the wheel well tomorrow. It had been completely destroyed.

The first photo shows the rebuilt rear vertical member what I need to attach to.

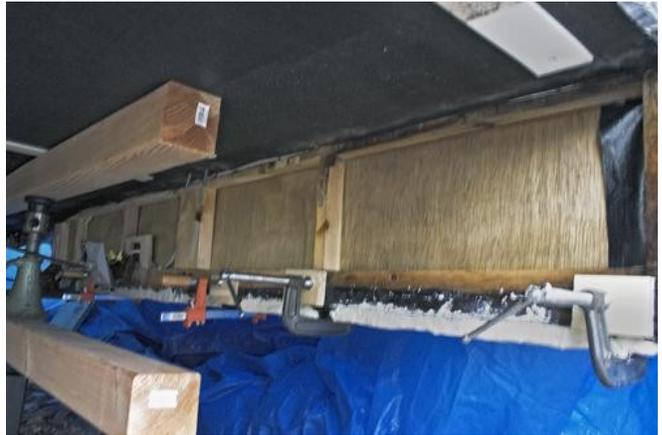
The second image is where the front of that member needs to attach. There is little or no attachment above.

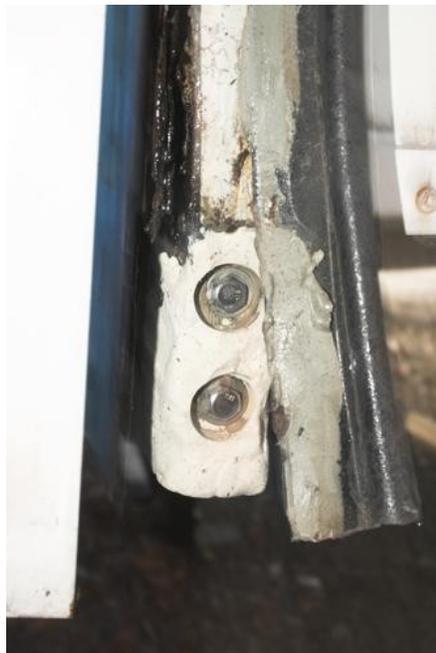
We had some early morning showers so the ground was wet and delayed by start. Jack assisted me in marking the 2x12 treated piece for the bottom frame at the wheel well. I took it to a friend with a band saw for cutting the radius. We then made some plates of 1/8" mild steel to tie the forward end of the 2x12 to the existing framing. This shown in the third photo.

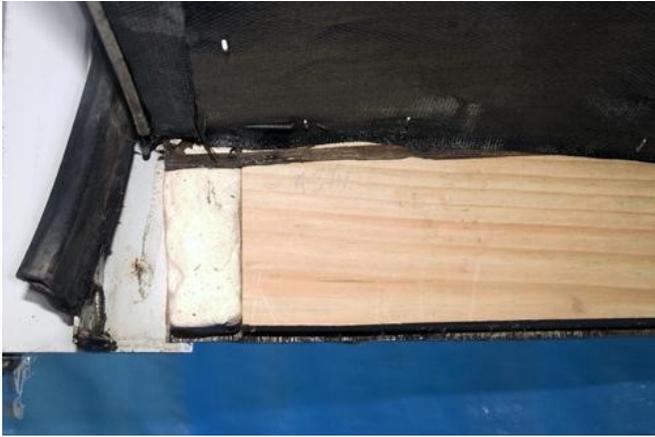
The first photo shows where I installed (2) 1/4"x5" lag screws into the rear end of the remaining part of the 2x12 also shown in photo number two. This made the bottom of the skirt very stable.

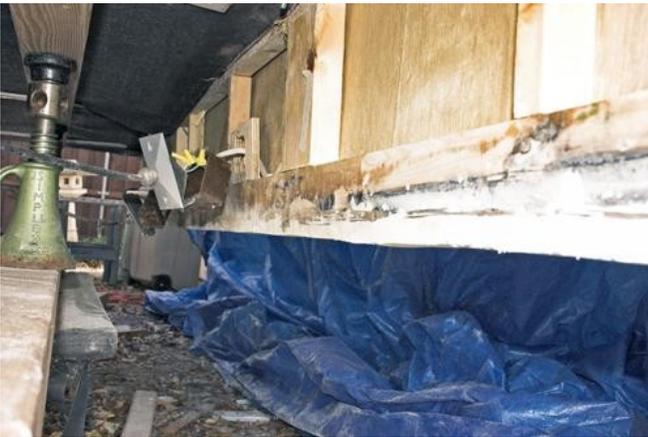
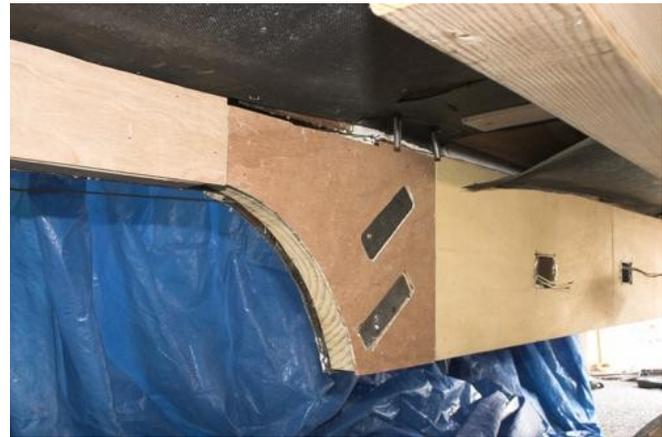
Yesterday it was too cold to work outside but it warmed up today. I sanded the framing member at the bottom of the exterior wall of the slide-out, squaring it so the plywood will lay smooth and the trim will fit properly at the bottom of the wall. I then installed the plywood gluing and stapling the luan. I had to cut out around the metal splicing plates. Turned out to be a good fit.

The pictures above show the progress. Unfortunately, I found some more rot at the base of the front and rear walls of the slide. That will be treated while we are working on the windows.

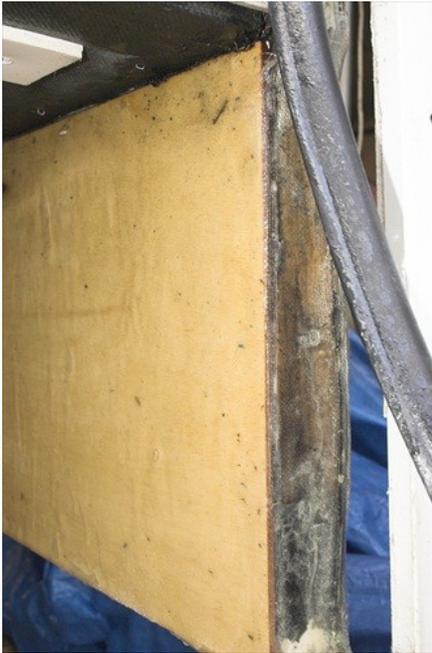
I finished putting on the fiberglass and coating with resin. The following photos show the clear fiberglass resin coating, the electrical yet to be connected and the slide mechanism back in position. We had to make a few adjustments to get the slide to come in O.K... Unfortunately, Jayne has a lot of weight permanently placed in the slide and the motor struggles to get it to rise over the rollers. Once up on the rollers, it moves pretty easy. I had to wrap the fiberglass cloth around the bottom and back on to the outside face of the slide. Had more problems there than anywhere during the job. It might not look the best but it will keep the water out.

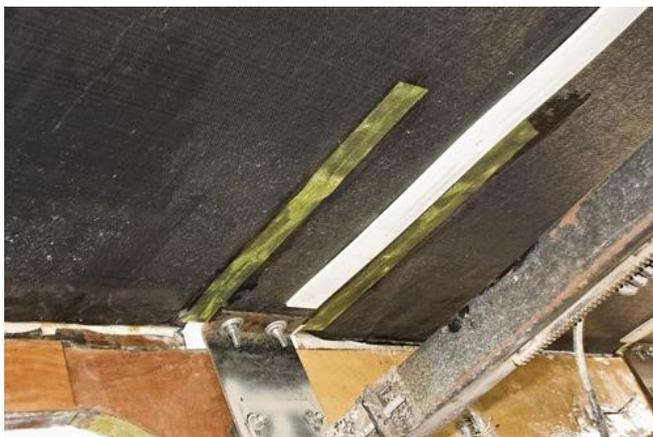
In the last photo you can see where I had to strip patch cuts in the weather barrier on the bottom of the slide. These cuts were made looking for the extent of the damage. Later today I will reinstall the wall end trim and tomorrow I will install the bottom trim and put another coat of resin on the weather barrier patches. That should take care of the job.

We finished her up today with the possible exception of the stripped cuts in the weather barrier. They might need another coat of resin, but they look pretty good. We put the trim on the bottom of the exterior wall of the slide and connected the electrical. Overall, the job looks pretty good.
